RE: Site Inspection, Uintah County and Crown Asphalt Corporation, Asphalt Ridge Mine, M/047/022 and M/047/032, Uintah County, Utah

Date of Inspection: April 11, 2003  
Time of Inspection: 9:30 to about 11:30 a.m.  
Conditions: Mostly clear, 70's  
Participants: Kim McDonald and Paul Felch (Uintah County), Lee Farber and Bill Kraemer (Crown Asphalt Ridge), Doug Jensen and Paul Baker (DOGM)

**M/047/022 and M/047/032, Asphalt Ridge Mine, Uintah County and Crown Asphalt Corporation**

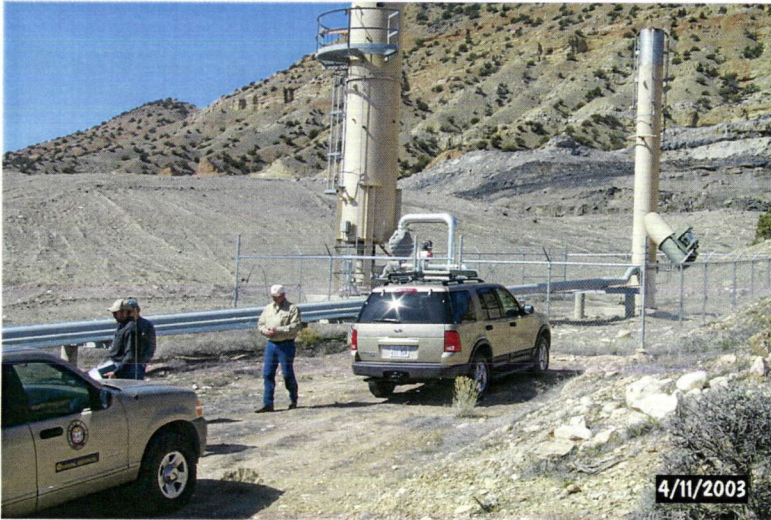
We first looked at a flare stack built north of the processing plant (Photo 1). This was apparently not anticipated in the original designs and is not included in the bond.

**Photo 1. The flare stacks.**

The map we examined would answer most of the questions the Division has raised recently about acreage figures and should also clarify the requirements for bonding. The operators need to submit this map for the Division's review. The area impacted by the flare stack and the flare stack facility will need to be included in the bond.

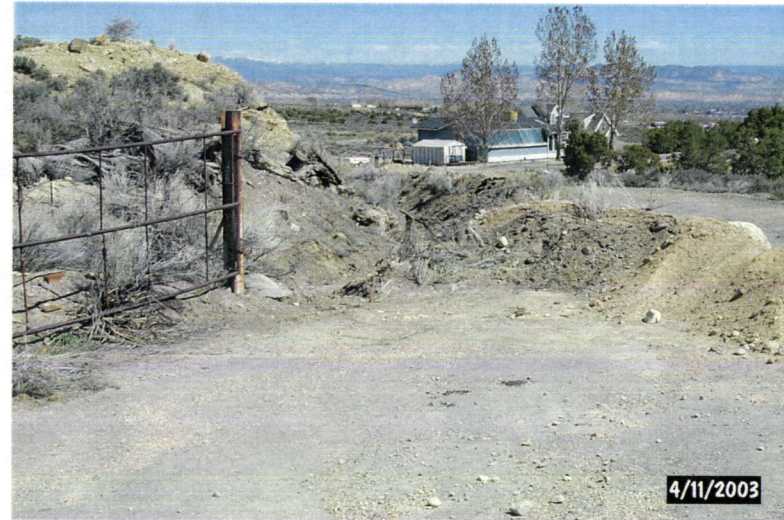
The operators have done most of the maintenance on the drainage control structures that we discussed last fall. Photo 2 shows a pond that would now capture any drainage coming out of this portion of the mine. Photo 3 shows a berm across the drainage below the pond in Photo 2, and this berm

and the ditch below it would capture all drainage coming from above this point. The ditch has been cleaned.

**Photo 3. A berm was placed across the road and an adjacent drainage (not in photo) to divert water to the ditch in the center of this picture.**

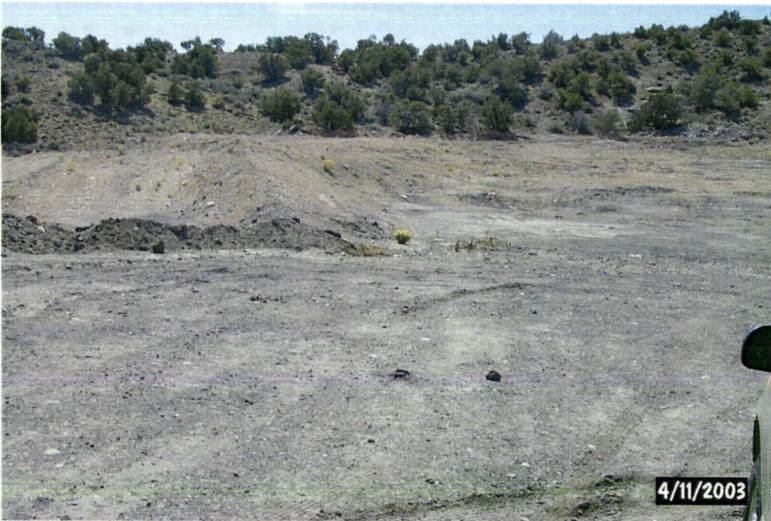
**Photo 2. Retention pond in the mine area.**
